# **Revision Guide for AMD Athlon™ 64 and AMD Opteron™ Processors**

Publication # <b>25759</b>	Revision: <b>3.69</b>
Issue Date: <b>September 2006</b>

# Revision Guide for AMD Athlon™ 64 and AMD Opteron™ Processors

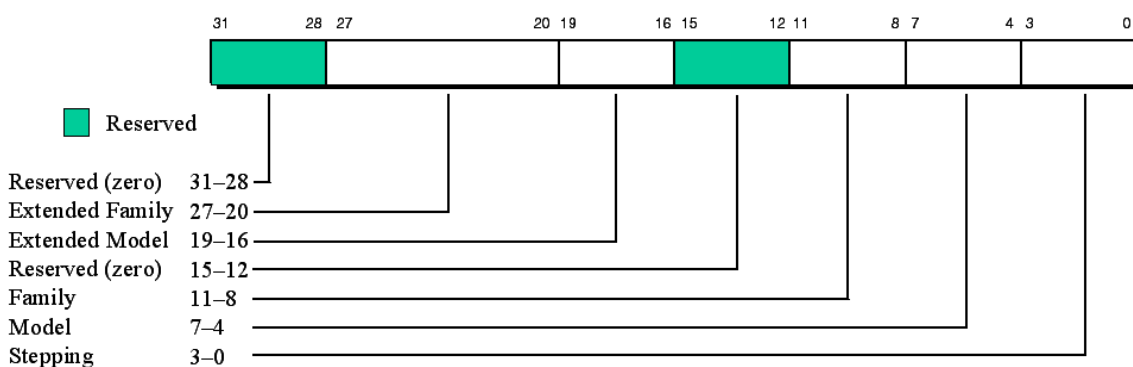
**Figure 1. Format of CPUID Value Returned by Function 1**

Figure 1 shows the format of the value returned in EAX by CPUID Function 1.
